Critical Reinforcement Design and Detailing for Resilience and Preservation of Concrete Structures

S. Munter¹, E. Lume¹

¹Steel Reinforcement Institute of Australia

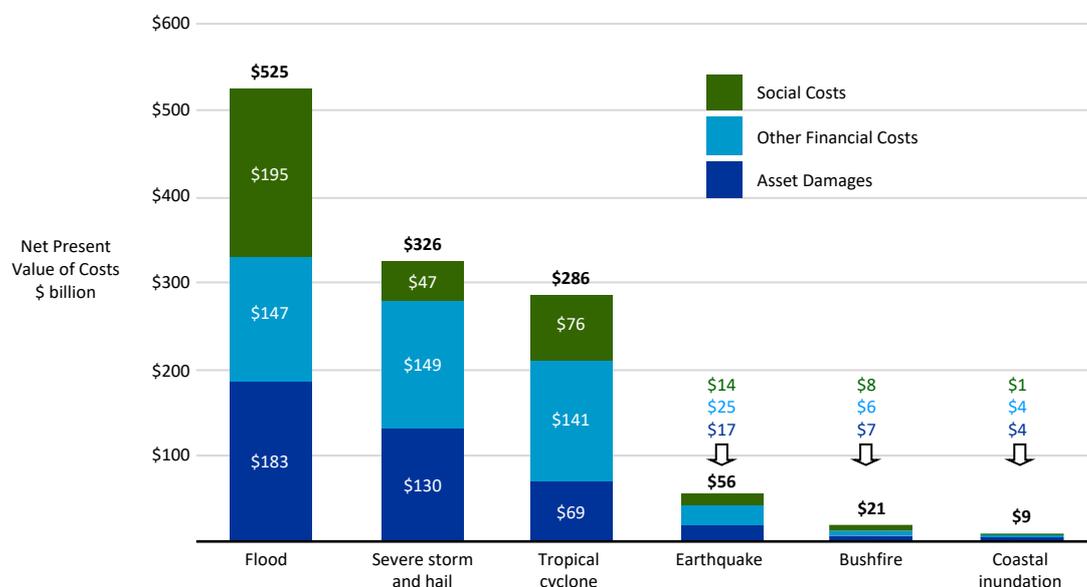
Figure 1 Predicted present value of economic costs and the components of costs under low emissions scenario by type of natural disaster over the next 40 years (from Deloitte Access Economics 2021[1])

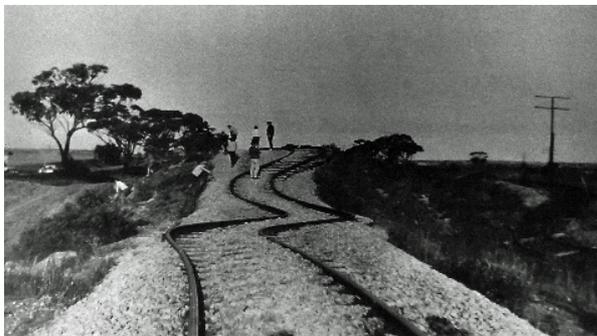
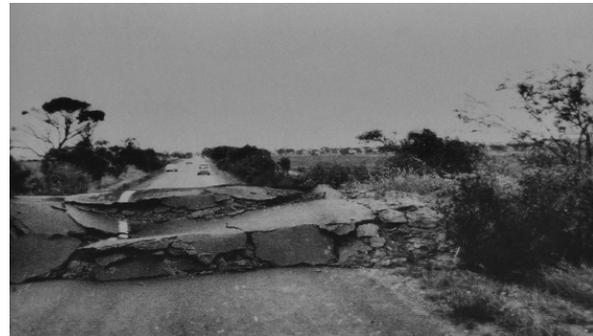
Figure 3 Fault line scarp from the Meckering, Western Australia 1968, Magnitude 6.9 earthquake.

The Adelaide event resulted in 3,000 buildings being damaged and 30,000 insurance claims. The Meckering event damaged or completely destroyed most structures and resulted in a 37 km long fault line scarp (**Figure 3**). The Newcastle event is considered one of Australia's worst natural disasters with damage extending over a 9,000 square kilometre area with movement up to 800 kilometres away (**Figure 4**). Aside from the estimated \$4 billion of damage to 35,000 homes, 147 schools and 3,000 buildings, the real tragedy was the 13 people that were killed, and further 160 that were hospitalised.

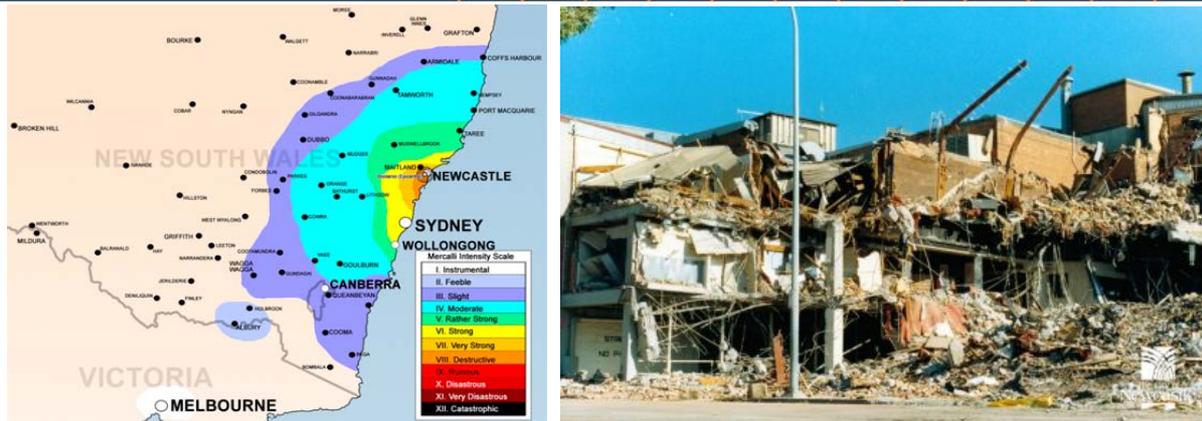
Figure 4 Influence of the Newcastle earthquake and damage to the Newcastle Workers Club, which was subsequently demolished and rebuilt (Photo Courtesy Newcastle Library).

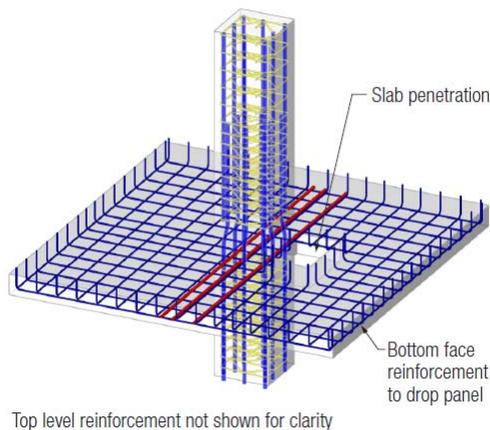
Figure 5 3D view of reinforcement at column-slab intersection showing structural integrity reinforcement in red (*detail courtesy of Wallbridge & Gilbert*)

Structural integrity reinforcement consists of a few reinforcing bars passing through the confined core of the column, which is the section within the column reinforcement cage **Figure 5**. This is critical, as research and evidence from past earthquakes has shown that the unrestrained cover concrete can be lost as a result of the lateral displacement of the structure or building during an earthquake **Figure 6**.

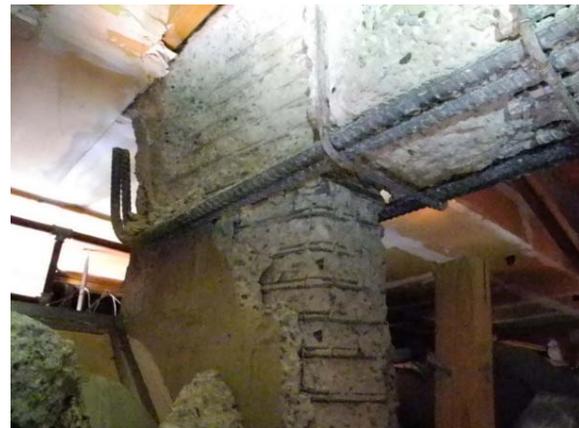
Figure 6 Unrestrained cover concrete to column of Copthorne Hotel in Christchurch lost during 2011 seismic event (*photograph courtesy Peter McBeam*)

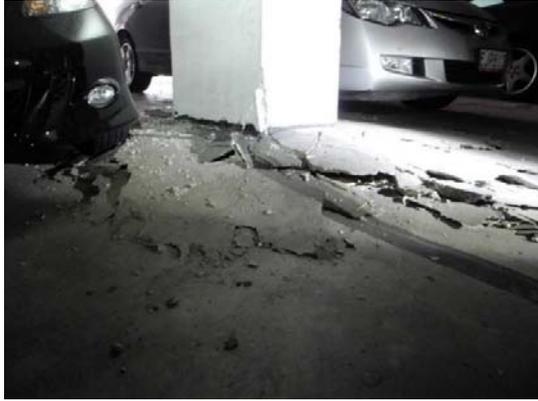
Figure 7 Punching shear failure with structural integrity reinforcement preventing collapse of slab, Hotel Grand Chancellor, Christchurch (photograph courtesy Peter McBean)

This nominal amount of reinforcement was found to be very effective at preventing the collapse of slabs following punching shear failures in Christchurch, improving the life safety of the building **Figure 7**. The Newcastle Workers Club is an example of punching shear failure where no structural integrity reinforcement was provided **Figure 8**. The benefits provided led the SRIA to include this aspect of detailing on the cover of the 2016 *Guide to Seismic Design and Detailing of Reinforced Concrete Buildings in Australia* [4], which is also freely available as a pdf copy from the SRIA website. While the Guide includes guidance on structural integrity reinforcement, it has come to our attention that the provisions for slabs that were included as Clause 9.2.2 of AS 3600 in 2018, are being misinterpreted. As a result, the SRIA has produced a new separate Technical Note 8 [5] to clarify the requirements for structural integrity reinforcement for slabs.

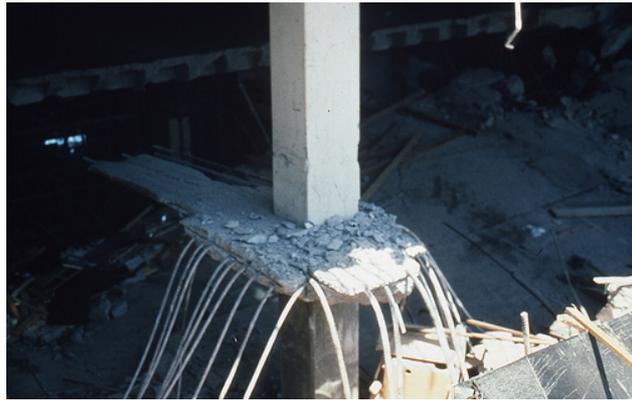
Figure 8 Punching shear failure at Newcastle Workers Club during the 1989 Newcastle earthquake – no structural integrity reinforcement to prevent risk of collapse (photo courtesy Cultural Collections, the University of Newcastle, Australia).

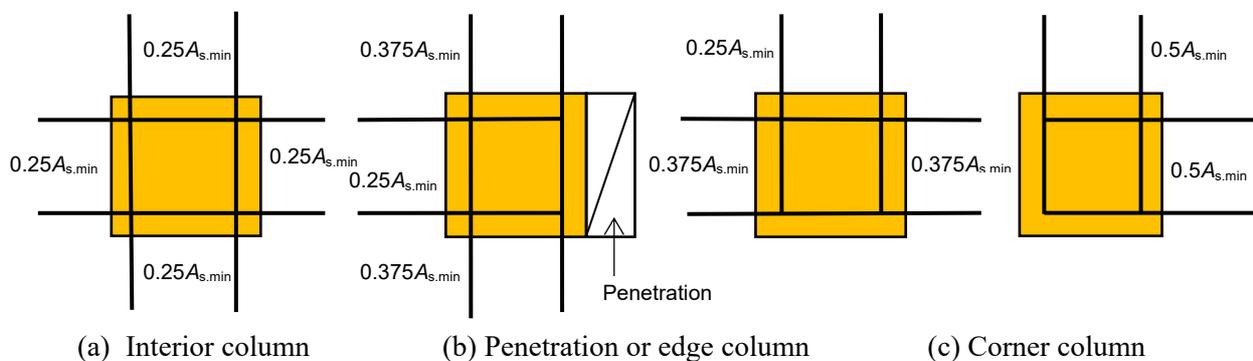
Figure 9 Example of the arrangement of reinforcement – total area all sides = $A_{s,min}$

The area of reinforcement required by Equation 9.2.2 should be distributed evenly on all faces of the column **Figure 9**. Note that it must be placed in the bottom of the slab, slab band or drop panel, otherwise it will not be effective in providing tensile membrane action to resist the gravity actions and reduce the risk of collapse. Referring to **Figure 8**, it can be seen that the top cover was lost and the top reinforcement, which was left exposed, was not effective at preventing collapse.

The structural integrity reinforcing bars are either spliced with existing bottom reinforcement in the slab in accordance with Clause 13.2 or AS 3600, or are provided as separate bars, extending a distance of $2L_{sy.tb}$ past the face of the column or column capital. They should have hooked or cogged ends at discontinuous edges, including penetrations.

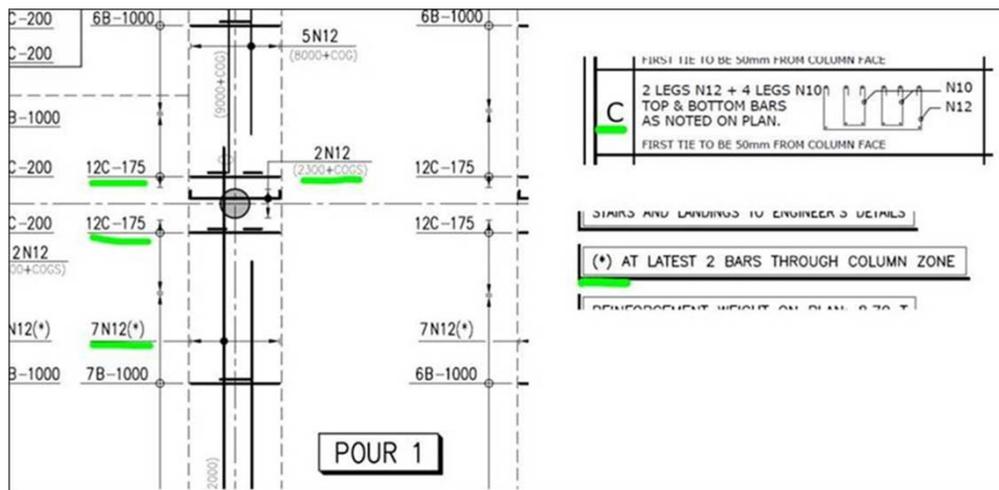
Figure 10 Example of nominal reinforcement to a slab band of a post-tensioned slab (from *SRIA Technical Enquiry*)

Note that the first paragraph of Clause 9.2.2 of AS 3600 specifically includes the connection of a slab band to a column. Often, some nominal reinforcement is provided to slab bands within post-tensioned slabs (refer example in **Figure 10**), but slab bands are not considered as beams in terms of structural integrity reinforcement and the nominal reinforcement that may be provided cannot be taken as satisfying structural integrity requirements based on the exemption given in Paragraph 2 of Clause 9.2.2 which states that: “Integrity reinforcement shall not be required if there are beams containing shear reinforcement and with at least two bottom bars continuous through the joint in all spans framing into the column.” The reference to beams is intended to refer to members that cannot punch and are designed in accordance with Section 8 of AS 3600, for which separate structural integrity reinforcement requirements apply.

Note that in the example shown in **Figure 10**, the 2N12 bottom bars in each direction can be included as part of required area of structural integrity reinforcement, $A_{s,min.}$.

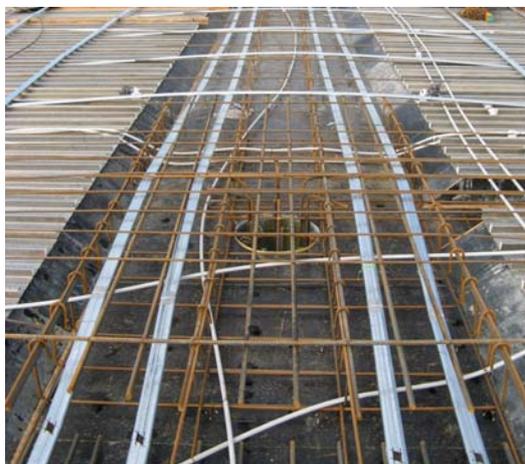
Figure 11 Post-tensioned slab band (from *SRIA technical enquiry*)

Another issue that we come across is whether post-tensioning can be considered as structural integrity reinforcement. Referring to **Figure 11**, there is no structural integrity reinforcement in the bottom of the slab band over the column. Note that the area of the post-tensioned bonded tendons in the top of the slab and/or slab band at column locations cannot be taken as part of the required structural integrity reinforcement for punching shear as they will fracture. The collapse of the Christchurch post-tensioned carpark slabs shown in **Figure 12** demonstrates the importance of providing the required structural integrity bottom reinforcement.

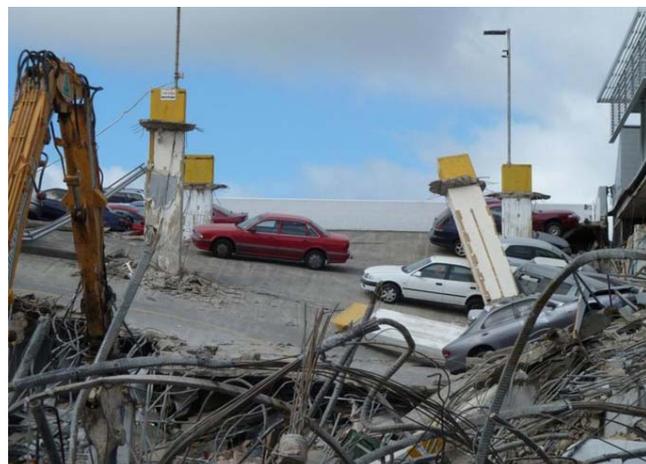
Figure 12 Remains of post-tensioned carpark floor at Christchurch, New Zealand showing punching shear failure at columns (photograph courtesy Peter McBean)

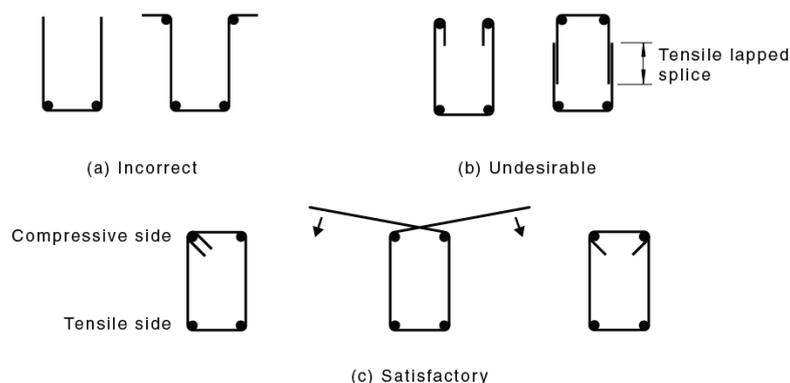
Figure 11 Anchorage of fitments in beams (Figure C8.3.2.4(B) of AS 3600 Commentary [6])

When the Commentary to AS 3600 [6] was published in March 2022, **Figure 13** was included to advise Engineers of satisfactory methods of providing anchorage to fitments. Every Engineer should have a copy of the Commentary and refer to it for additional background information and clarification of clauses. According to the Commentary to AS 3600, the open fitments shown in **Figure 13** “do not provide confinement for the concrete in the compression zone and is undesirable in heavily reinforced beams where confinement of the compressive concrete may be required to improve ductility of the member.”

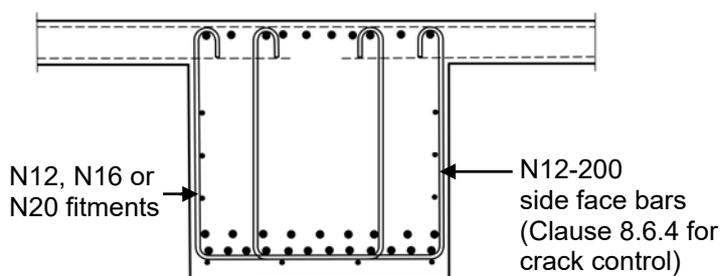
Figure 14 Example of open fitments to transfer beam

Another issue with open fitments such as shown in **Figure 14**, is that the compression reinforcement may not be adequately restrained. Hooks to anchor fitments (as shown at top of beam):

- Do not form a closed fitment – refer Clause 1.6.3.12 of AS 3600.
- Are not satisfactory as torsional reinforcement, which requires closed fitments according to Clause 8.3.3(a) of AS 3600.
- Clause 8.3.1.6 of AS 3600 states that: “Compressive reinforcement required for strength in beams shall be adequately restrained by fitments in accordance with Clause 10.7.4”. Note that if perimeter beams are being used as chord members in the design of diaphragms, they should also be designed as columns to cater for the compression loads.

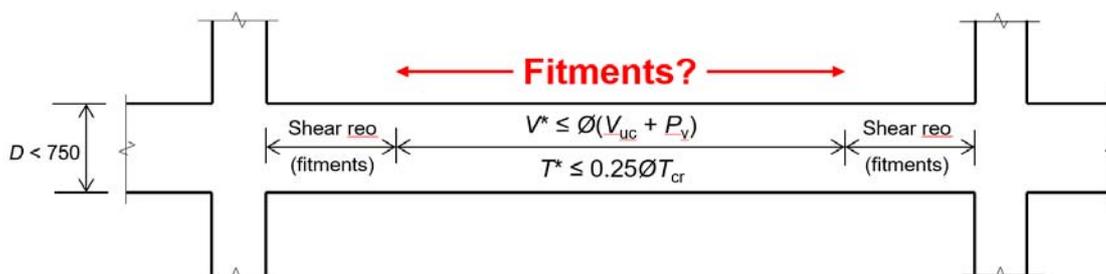
Figure 16 Length where no requirement exists for spacing of fitments

Therefore, when $V^* \leq \phi(V_{uc} + P_v)$ and $T^* \leq 0.25\phi T_{cr}$ and the overall depth of the member $D < 750$ mm, there is no requirement for shear reinforcement. However, some fitments still need to be provided to allow assembly of the reinforcement and hold it securely during construction and placement of the concrete, and will also assist if the beam is subjected to any overloads **Figure 16**.
