## Veneer Construction

In order to provide a technical resolution the NPCAA, in 1999, commissioned Mahaffey Associates to undertake research into the technology and history of veneering in precast concrete applications.

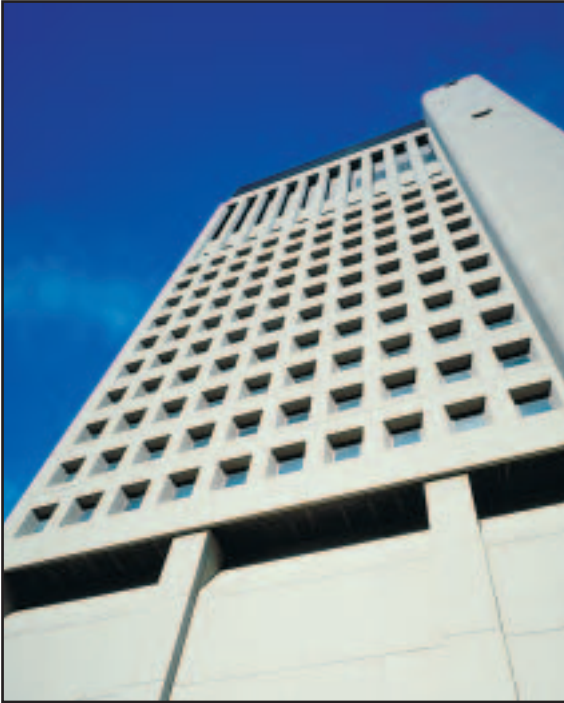
Commonwealth Bank Building, Sydney – an example of a high quality, durable veneered facade

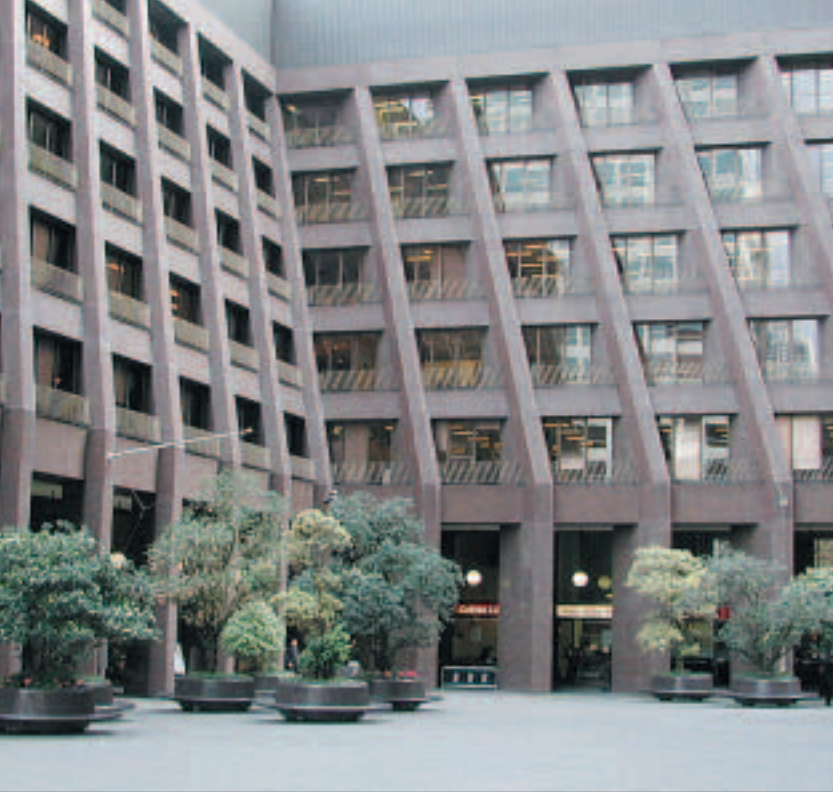
AMP Centre (Tower and St James Building), Melbourne – an example of a veneered facade from the 1960's
