ASEC
AUSTRALASIAN STRUCTURAL
ENGINEERING CONFERENCE 2016

Role of Engineers in Seismic Design and Detailing of Reinforced Concrete Buildings in Australia

Scott Munter, Executive Director SRIA

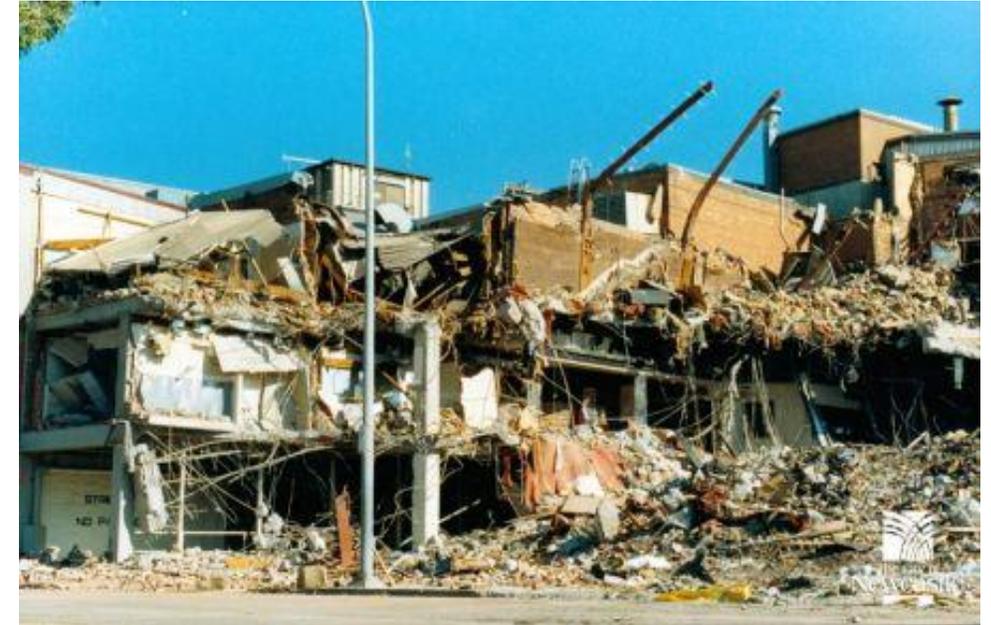
The Newcastle Worker Club
Subsequently demolished & rebuilt
(Photo Courtesy Newcastle Library)

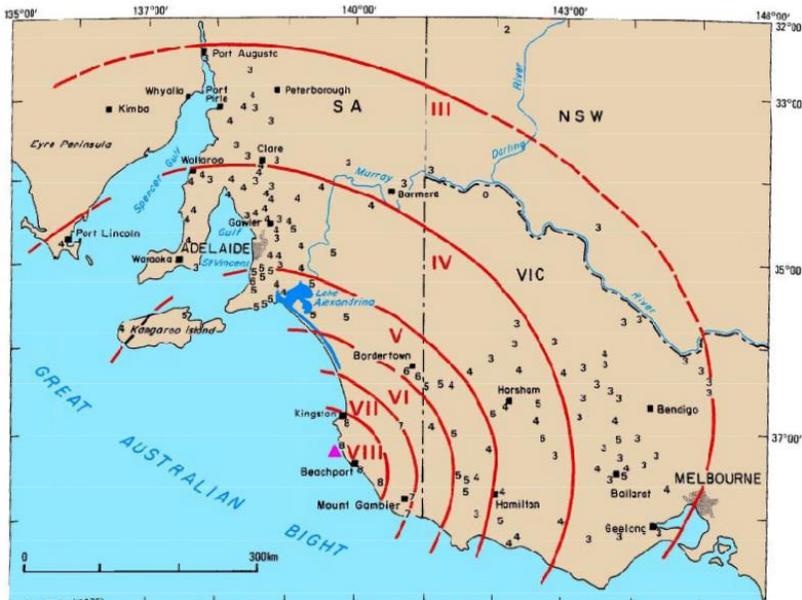
Isoseismal map

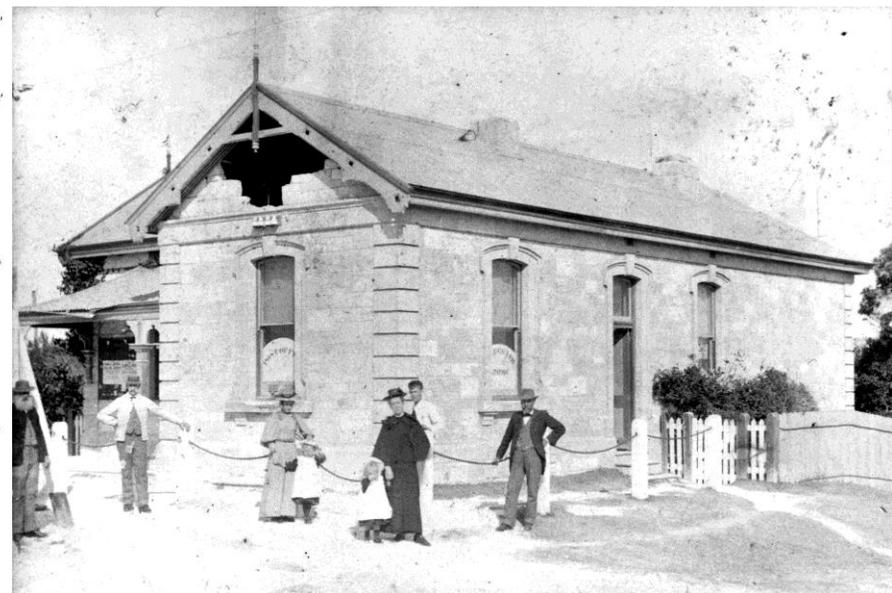
Damage to Beachport Post Office

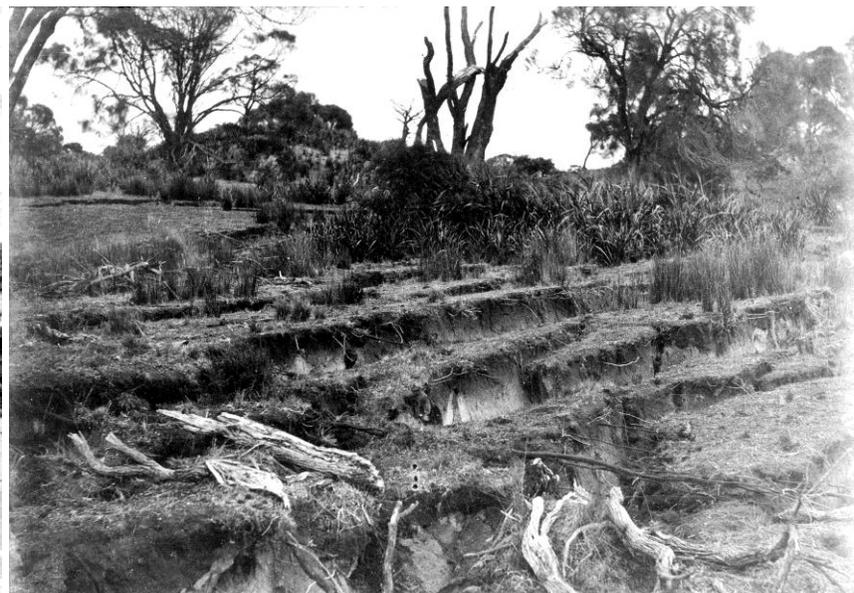
Slumping near Robe due to liquefaction

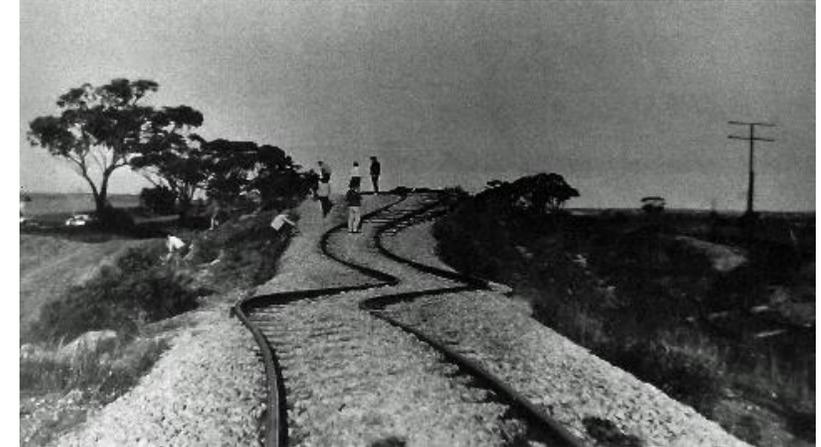
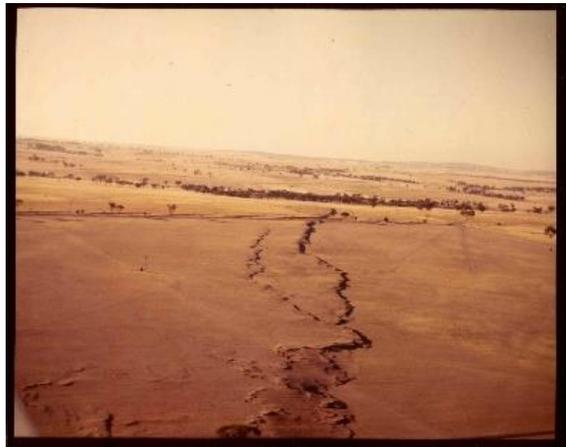
37 km fault line scarp

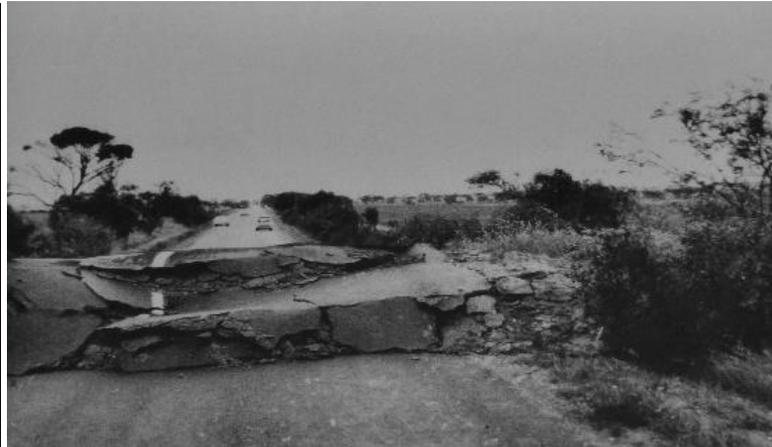
Height of step 1.5 m

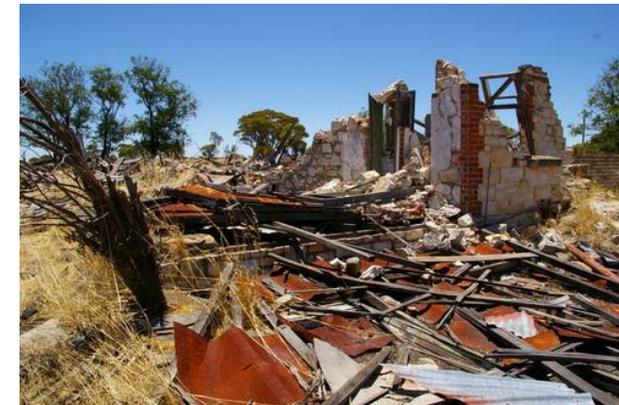
Most structures damages
or completely destroyed

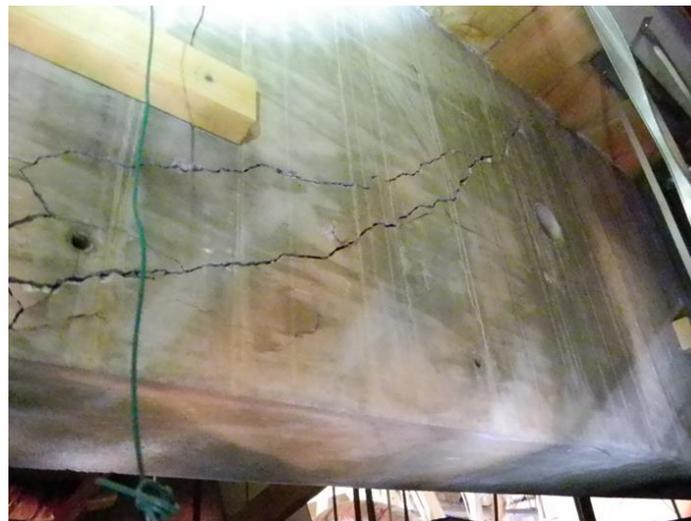
Transfer beam - stiffness of structure changes with cracking

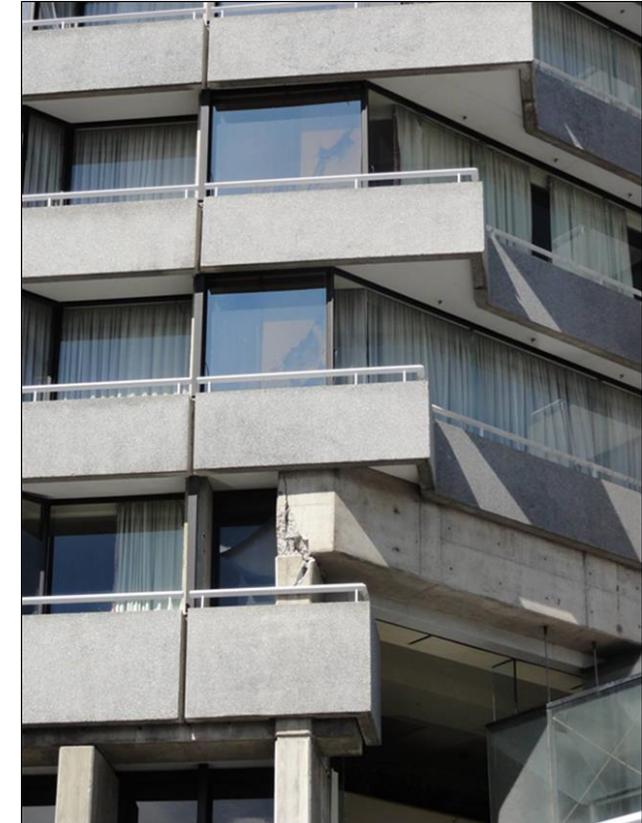
Provide simple load paths

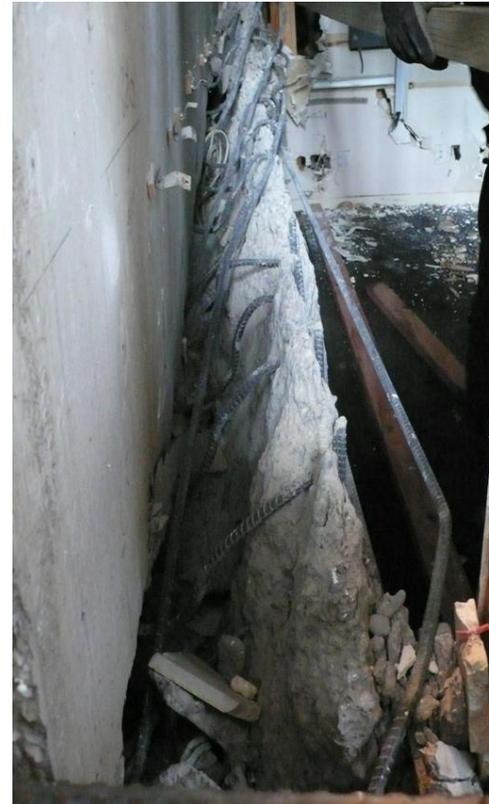
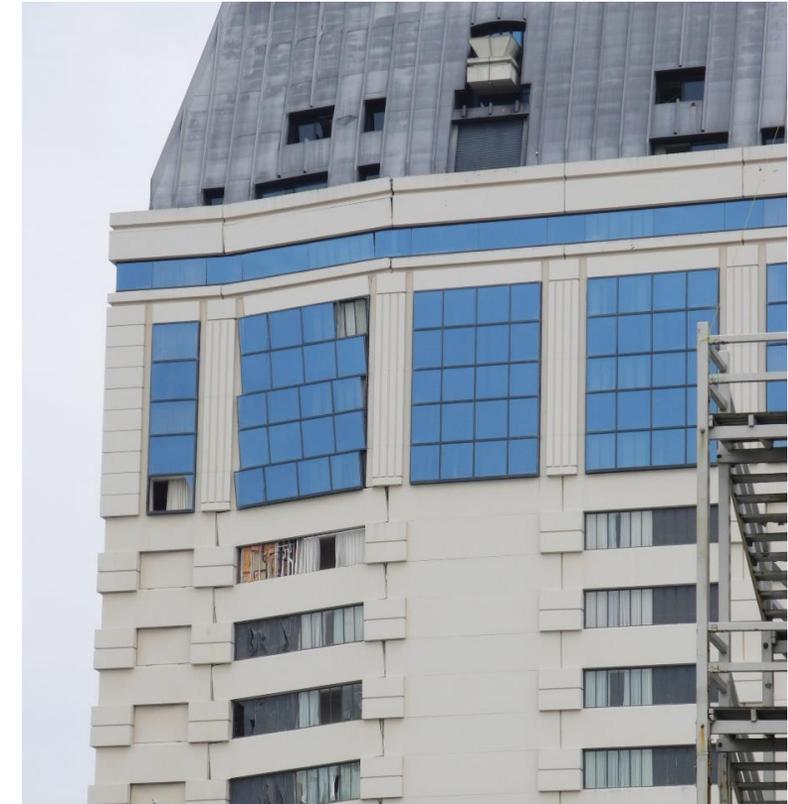
Failure of loadbearing shear wall did not result in collapse
of entire building
Hotel Grand Chancellor, Christchurch

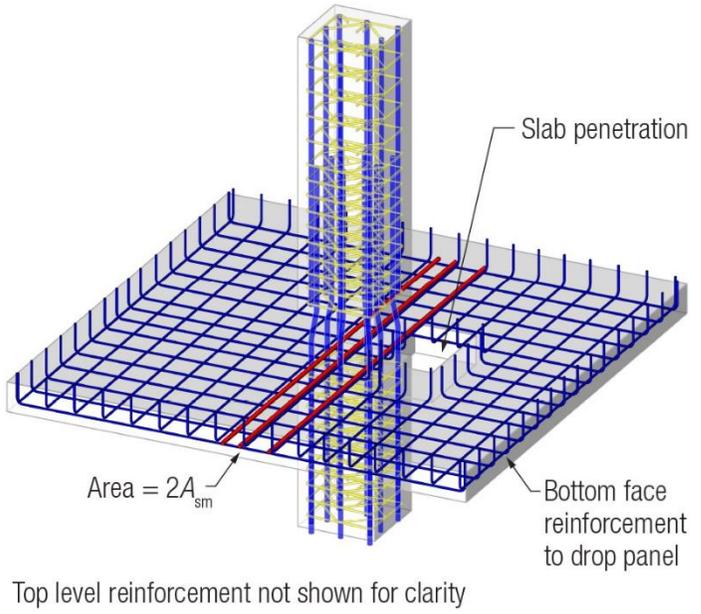
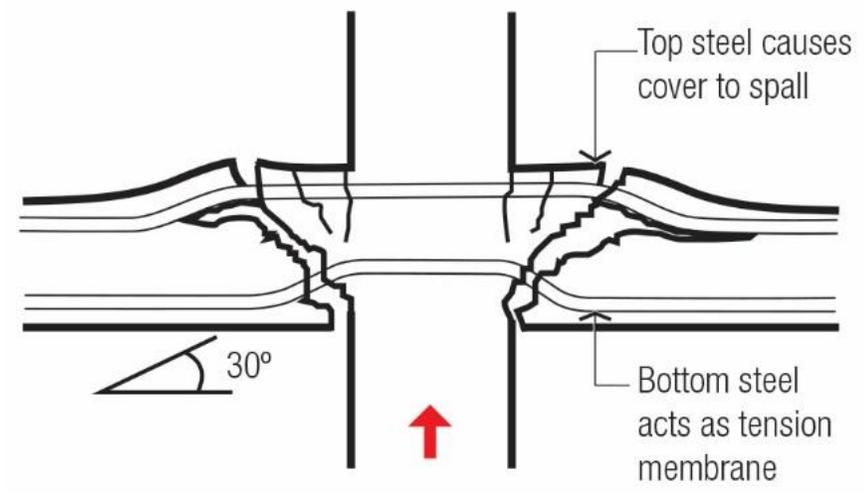
Figures 36 and 37 from Seismic Guide

Increases resistance of structural system to progressive collapse

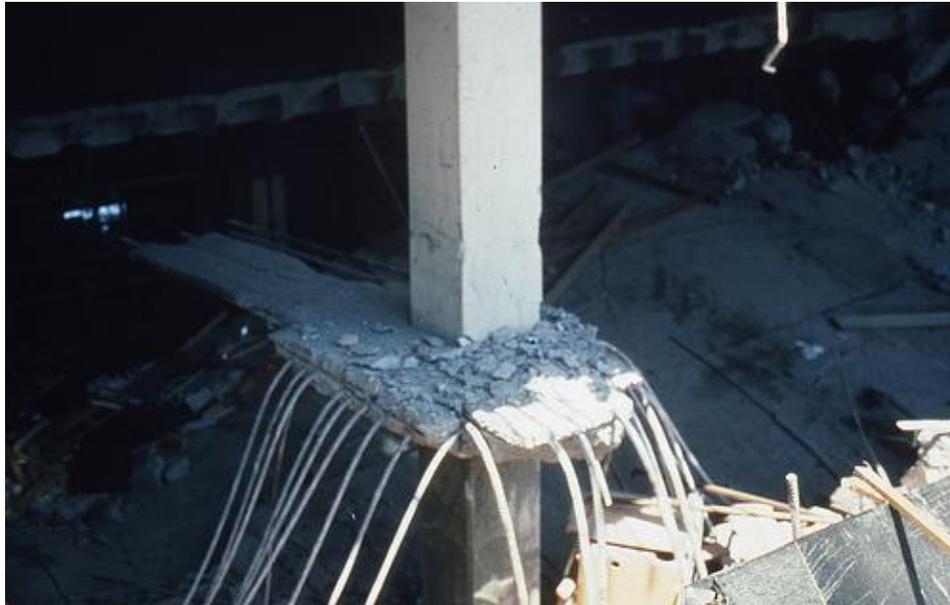
Punching shear failure at column

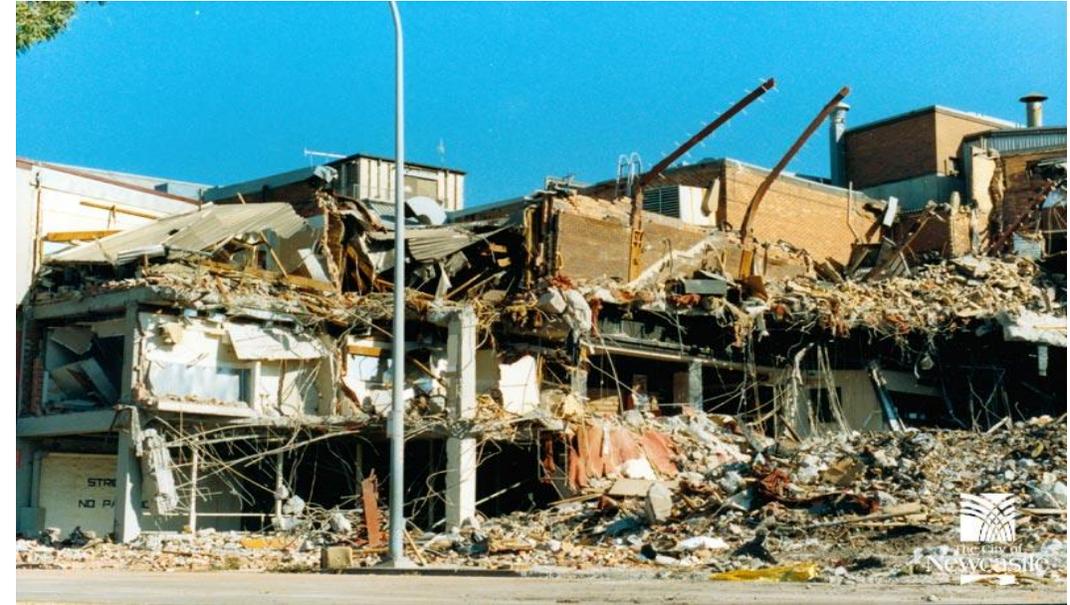
Resultant progressive collapse

Remains of car park floor – Old Newcastle Workers Club, NSW

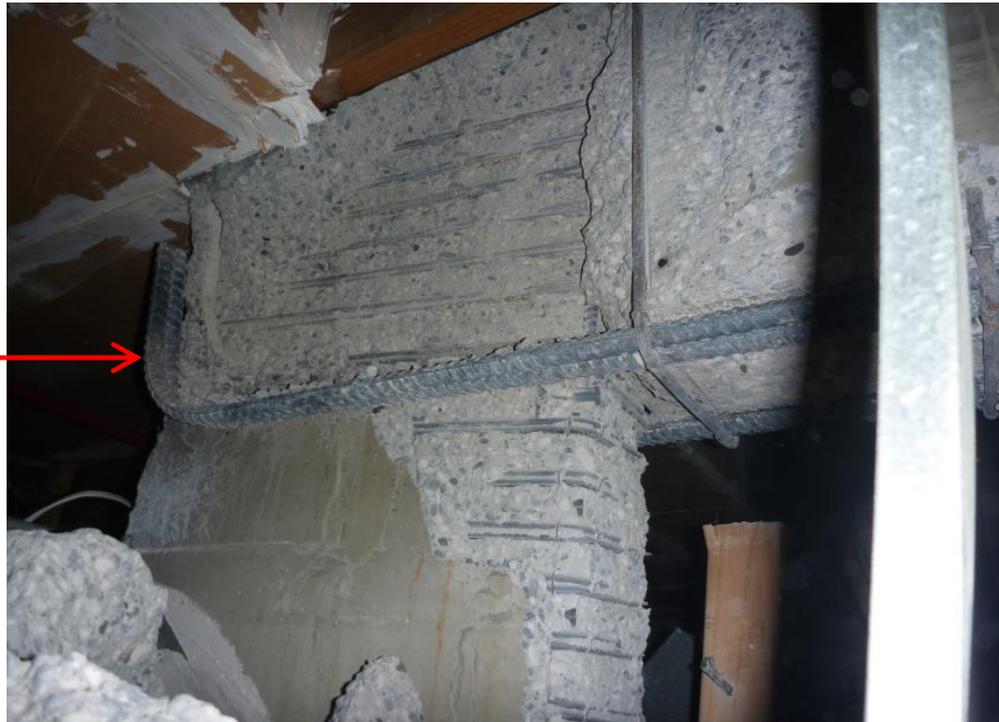
Bottom bars not adequately anchored in the confined region of the column

Failure of a beam column joint
Cophthorne Hotel, Christchurch 2011

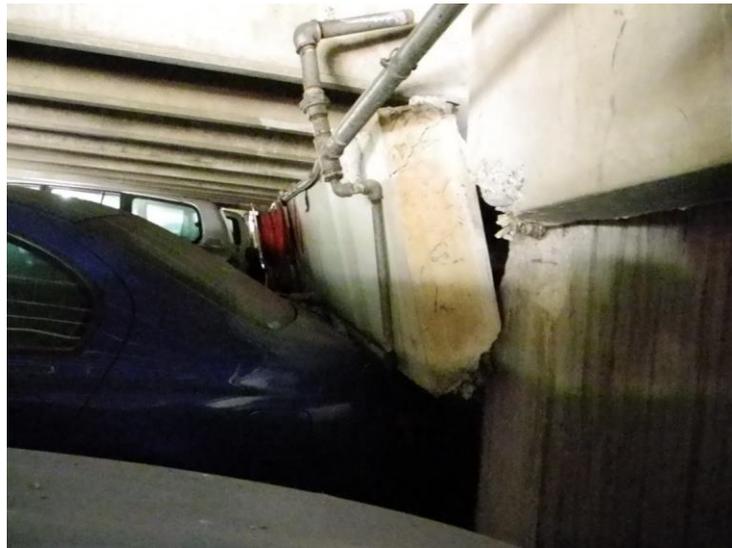
Failure of precast connection
Bedford Row Carpark
Christchurch, NZ

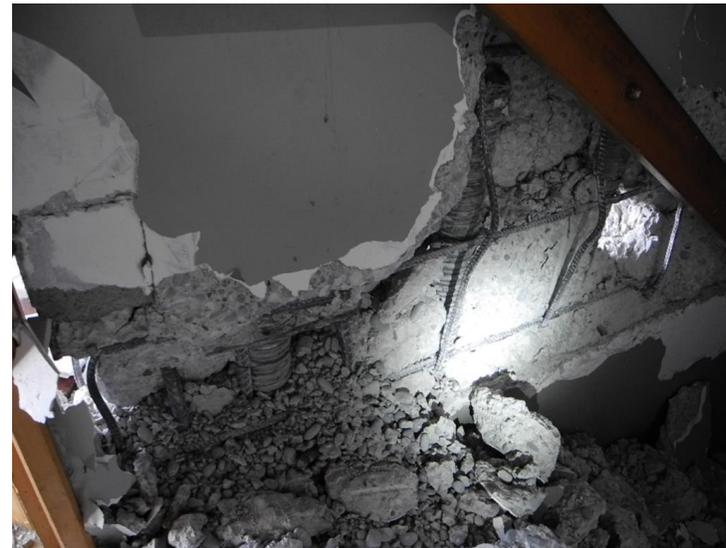
Failure of precast connection
Crown Plaza Hotel
Christchurch, NZ

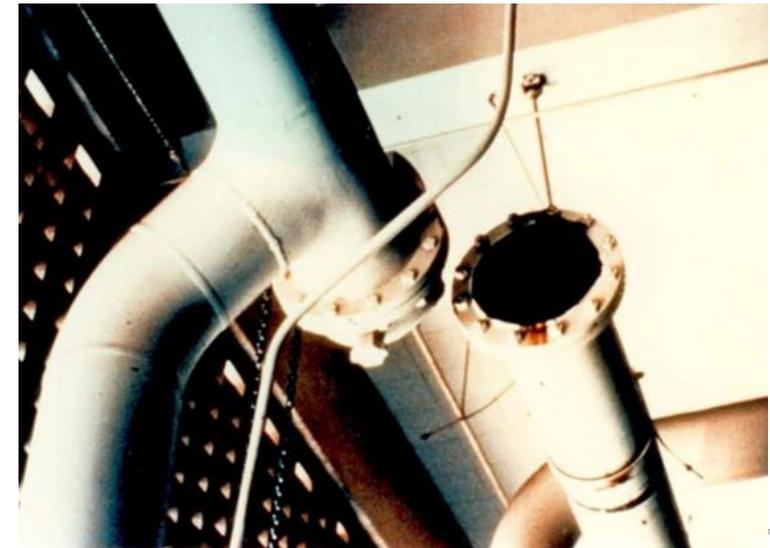
Pipe joint failure
San Fernando Earthquake, 1971
(FEMA 74, 1994)

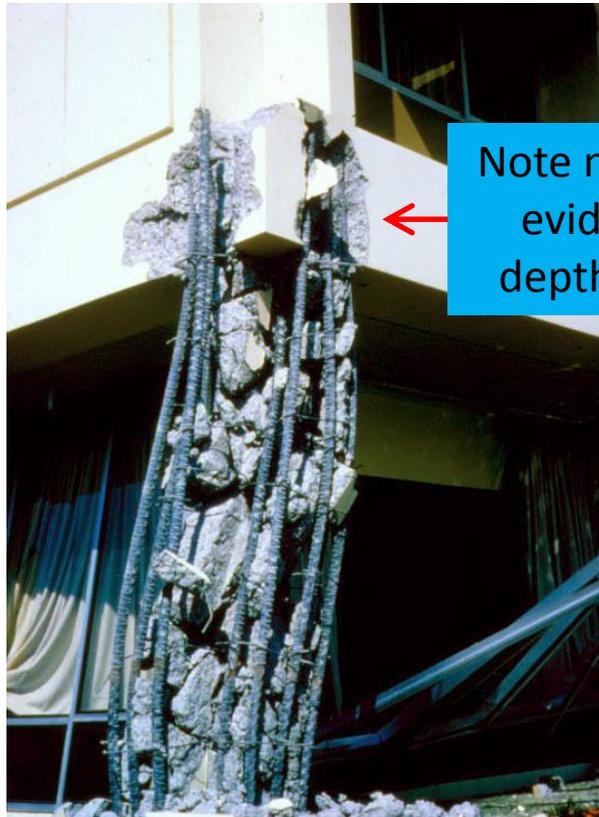
Note no fitments
evident over
depth of beam

Loss of confined core due to fitment failure
Kobe earthquake, Japan 1995

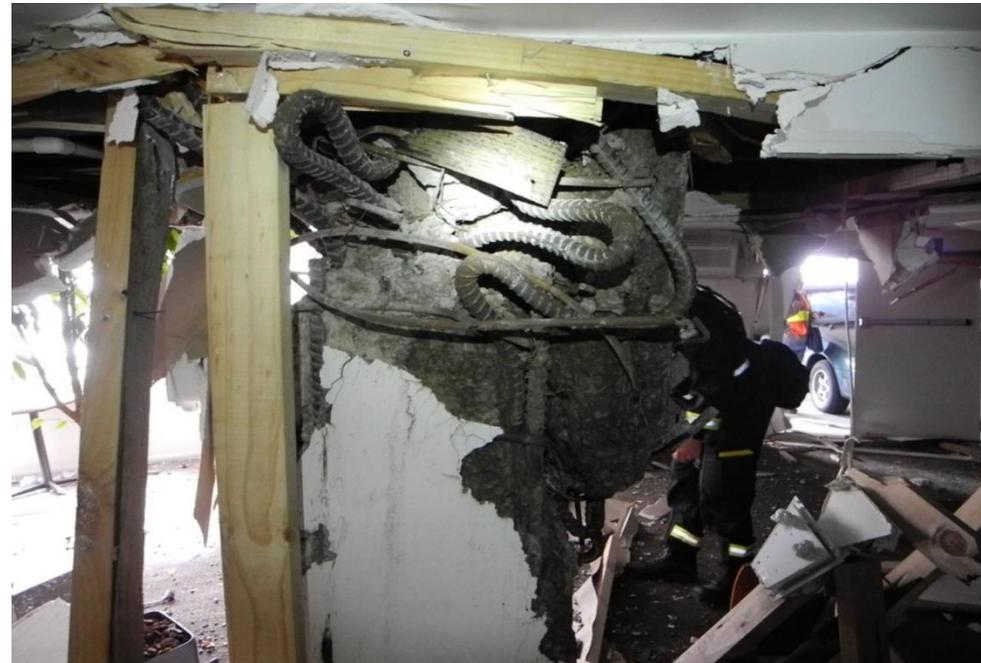
Restraint of longitudinal bars lost due to fitment failure
Hotel Grand Chancellor, Christchurch, NZ 2011

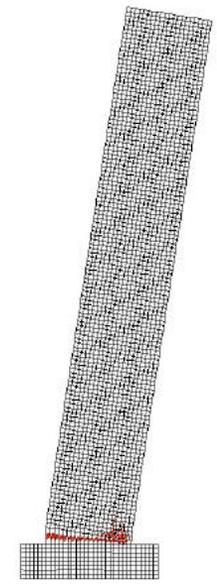
(b) As-built grid-F

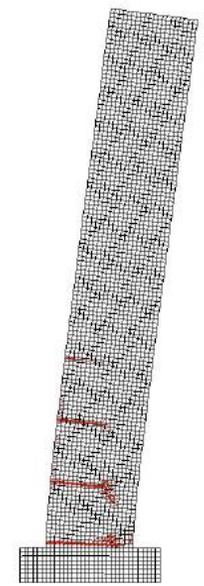
(c) NZS 3101 (A2)

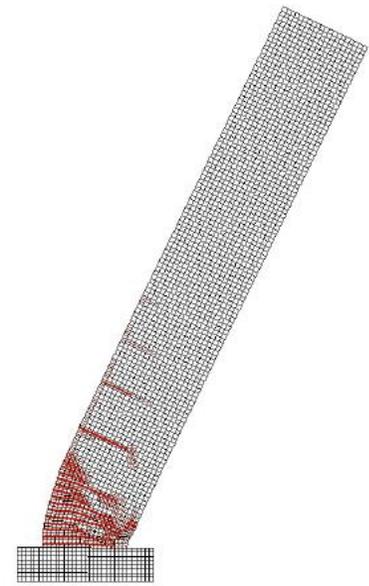
(d) Additional reo at ends

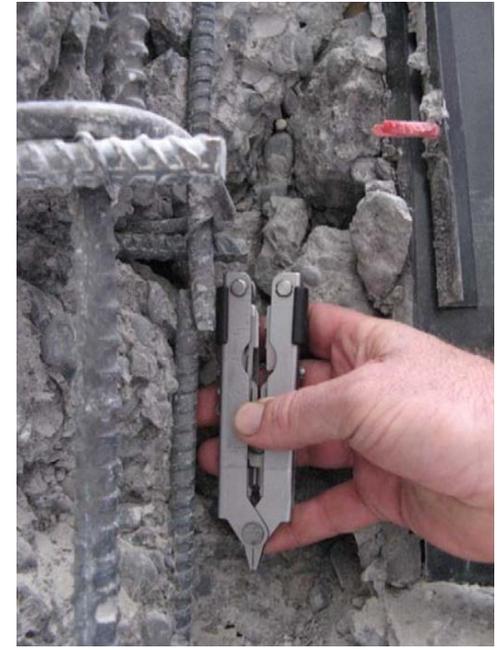
Fractured reinforcement at base of wall – Grid F

Actual damage and crack patterns from wall models

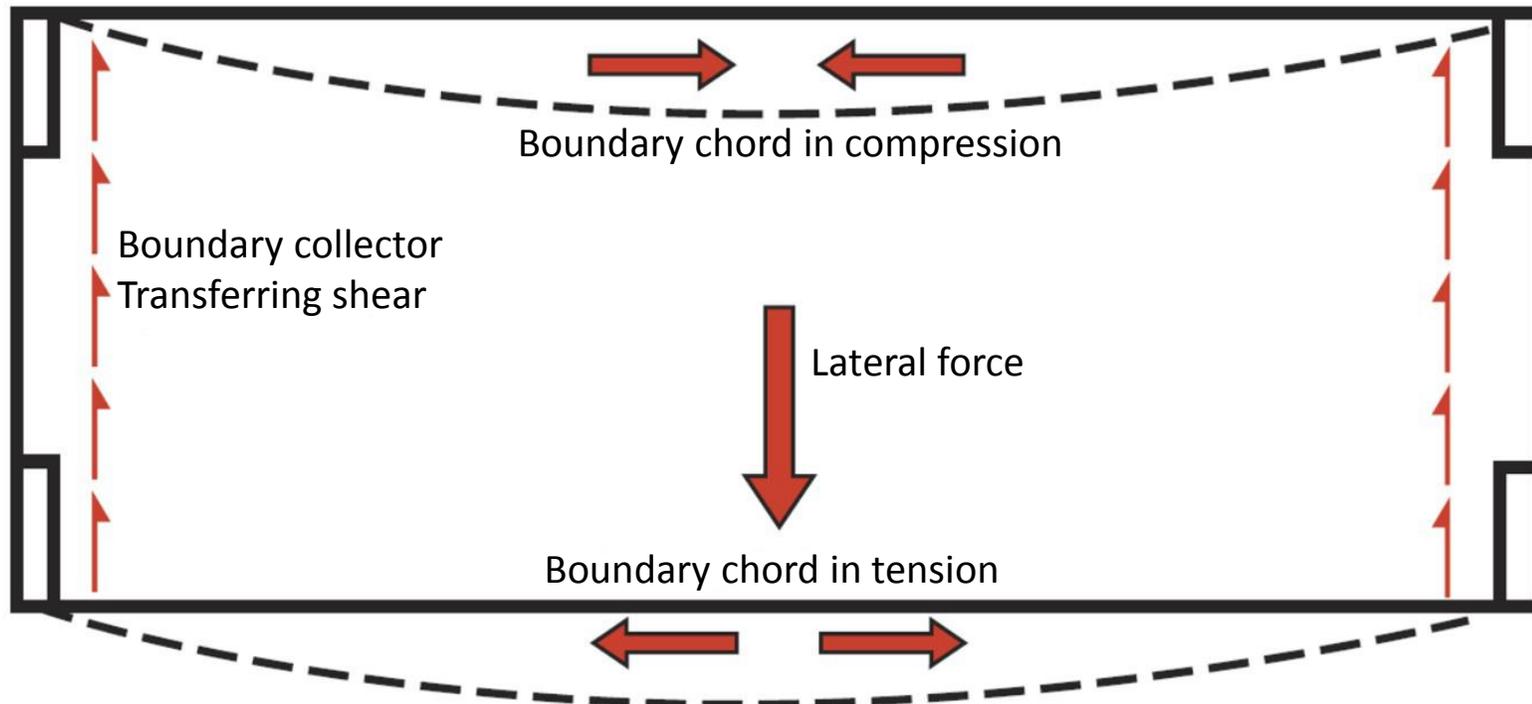
Floor as diaphragm
(after ATC/SEAOC briefing paper)

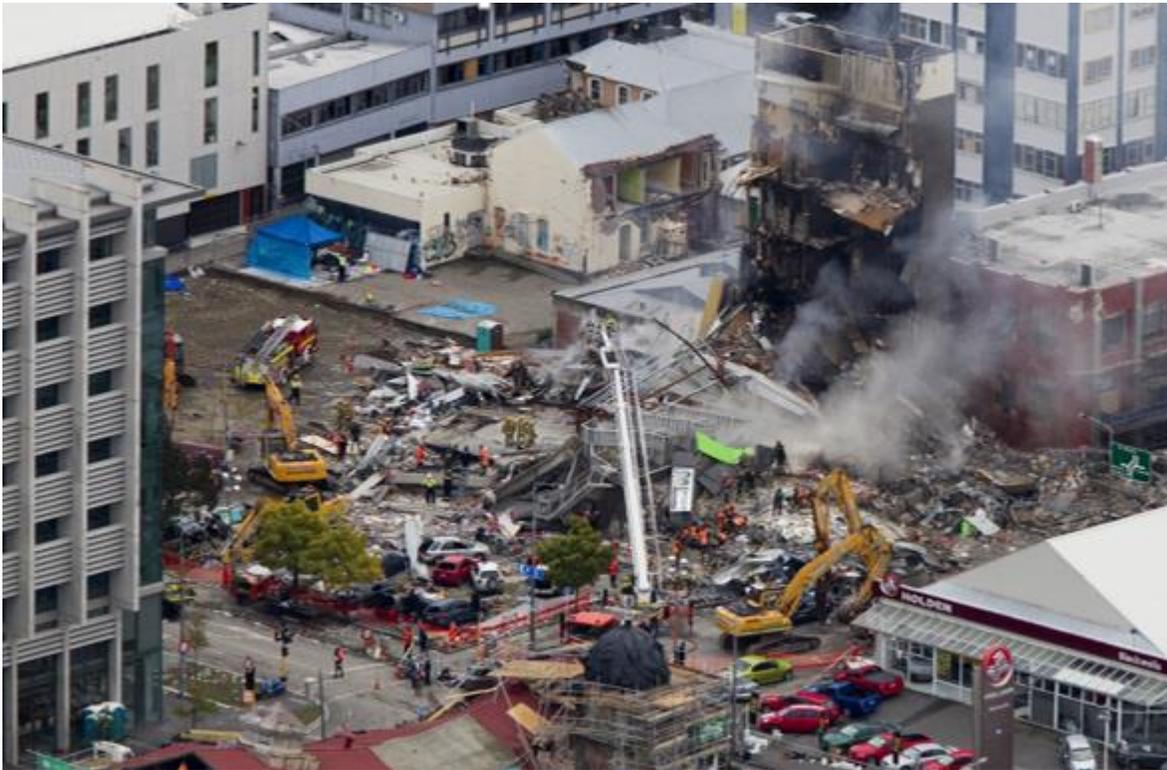
Ensure connection to shear resisting elements is adequate

CTV Building, Christchurch, NZ

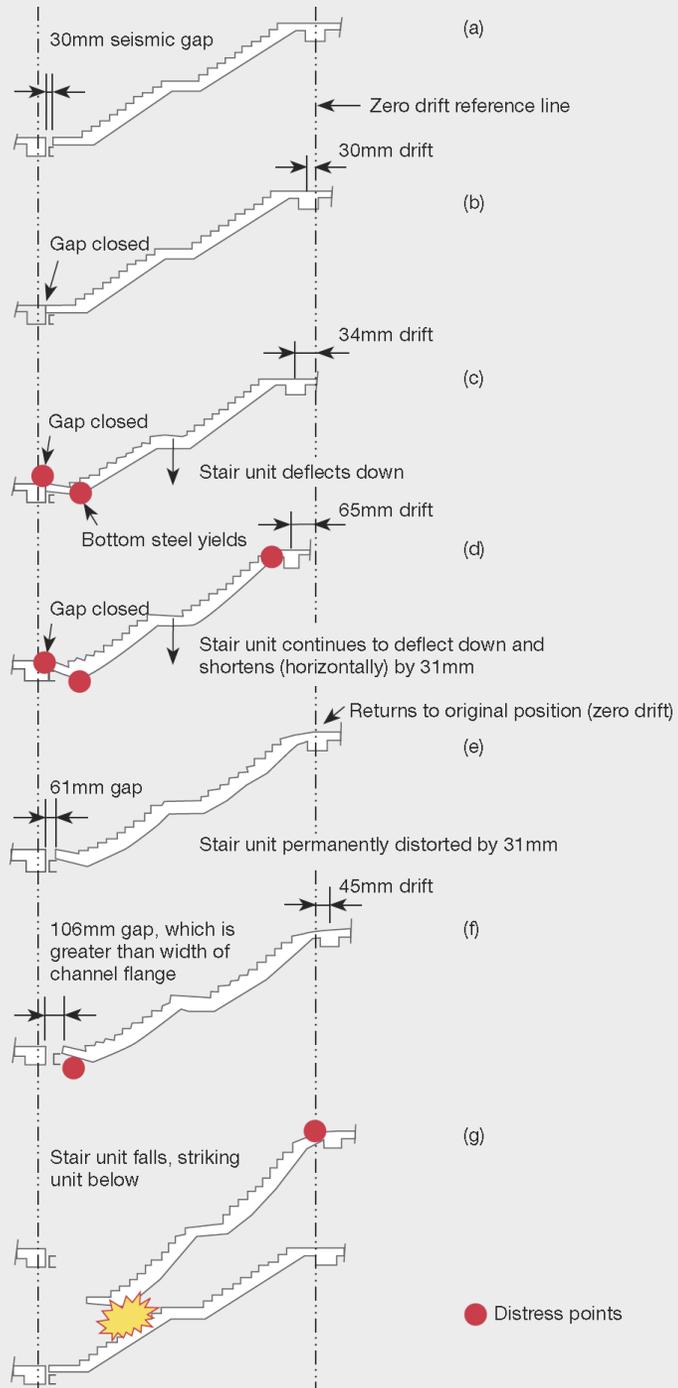
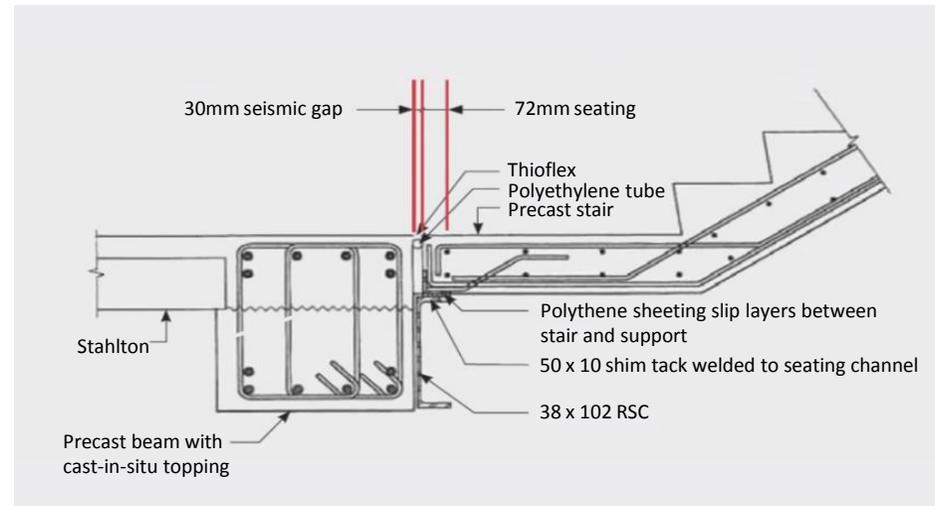
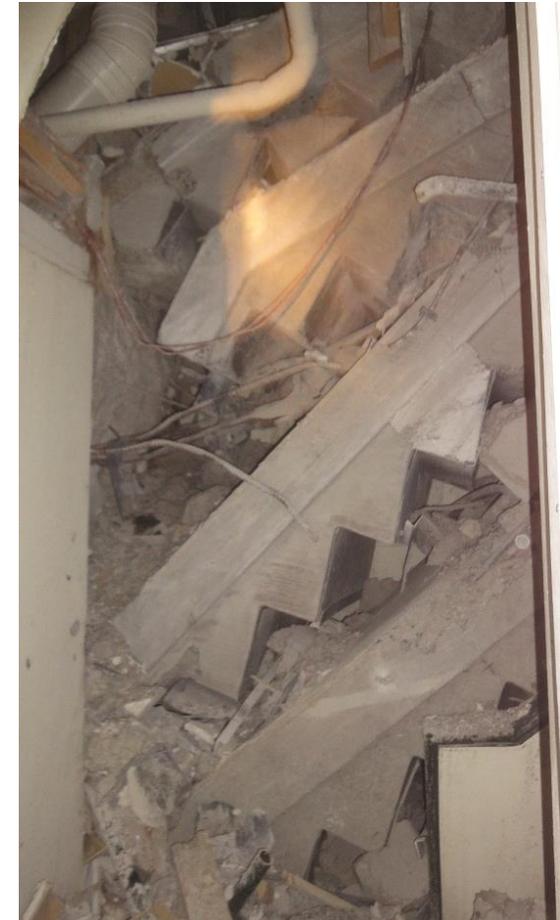
Must allow for an interstorey drift of $1.5d_{st}$
(where $d_{st} = 1.5\%$ of storey height)

Collapsed stairs to the Hotel Grand Chancellor
(Photograph courtesy of Dunning Thornton Consultants Ltd, NZ)
