STRUCTURAL INTEGRITY REINFORCEMENT FOR SLABS

In 2018, based on the lessons learnt from the Christchurch, New Zealand earthquake events in 2011, AS 3600¹ was revised to incorporate many new provisions to safeguard future Australian buildings from seismic events and provide important life safety to the occupants if the buildings are subjected to one of these extreme events.

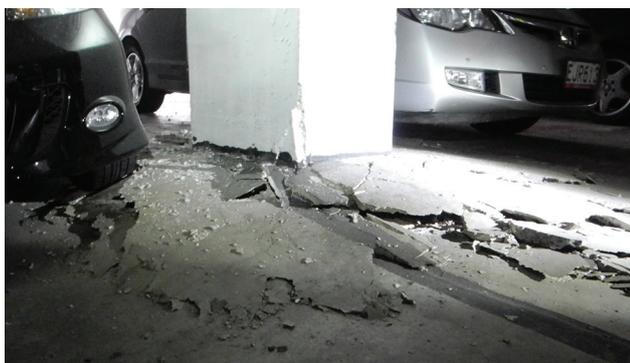
Figure 1 Punching shear failure with structural integrity reinforcement preventing collapse of slab, Hotel Grand Chancellor, Christchurch

One simple reinforcement detailing requirement that was incorporated into the Standard was structural integrity reinforcement for both beams and slabs. This nominal amount of reinforcement was found to be very effective at preventing the collapse of slabs following punching shear failures in Christchurch, improving the life safety of the building **Figure 1**. The Newcastle Workers Club is an example of punching shear failure where no structural integrity reinforcement was provided **Figure 2**. The benefits provided by structural integrity reinforcement led the SRIA to include this aspect of detailing on the cover of the 2016 *Guide to Seismic Design and Detailing of Reinforced Concrete Buildings in Australia*, which is also available for free as a pdf copy from the SRIA website. While the Guide includes structural integrity reinforcement, it has come to the attention of the SRIA that the provisions for slabs that were included as Clause 9.2.2 of AS 3600 in 2018, are being misinterpreted. This Technical Note is intended to clarify the intent and requirements of AS 3600 for structural integrity reinforcement for slabs.

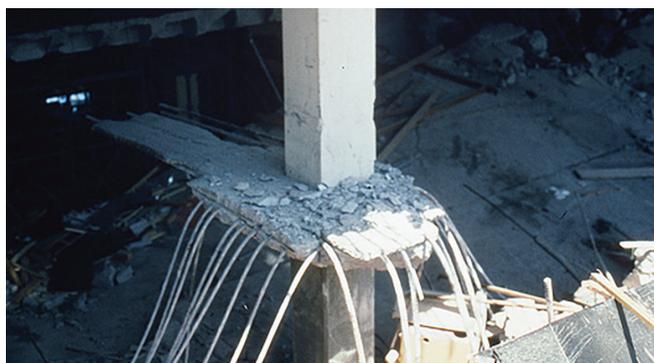
Figure 2 Punching shear failure at Newcastle Workers Club during the 1989 Newcastle earthquake – no structural integrity reinforcement to reduce the risk of collapse

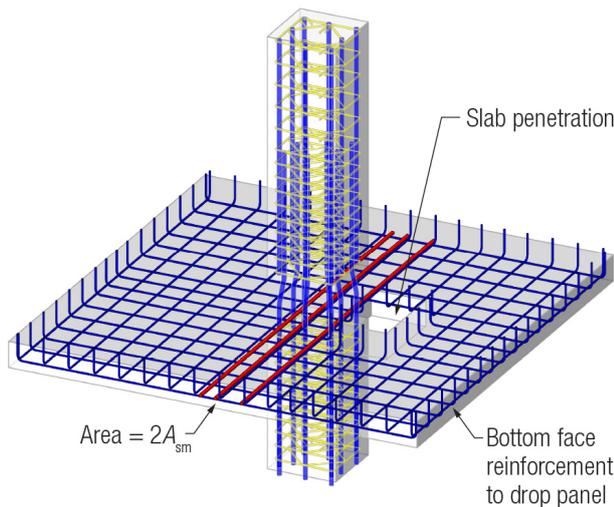
Top level reinforcement not shown for clarity

Figure 3 3D view of reinforcement at column-slab intersection showing structural integrity reinforcement in red (detail courtesy of Wallbridge & Gilbert)

Structural integrity reinforcement is nothing more than a few reinforcing bars passing through the confined core of the column, which is the section within the column reinforcement cage **Figure 3**. This is critical, as research and evidence from past earthquakes has shown that the unrestrained cover concrete can be lost as a result of the lateral displacement of the structure or building during an earthquake **Figure 4**.

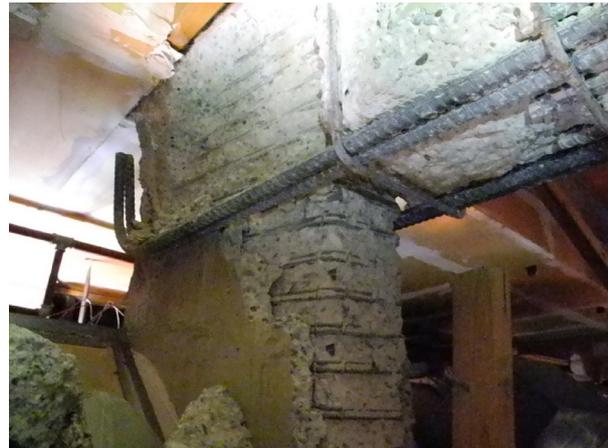
Figure 4 Unrestrained cover concrete to column of Cophthorne Hotel in Christchurch lost during 2011 seismic event (photograph courtesy Peter McBean)

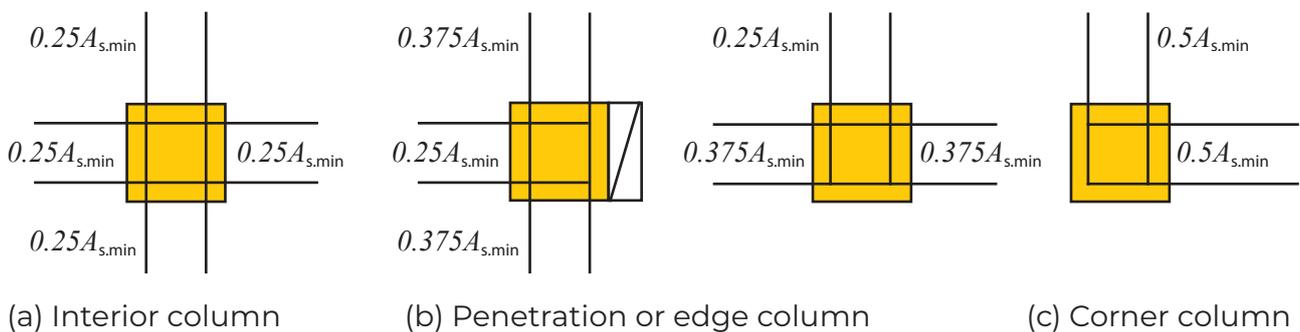
Figure 5 Example of the arrangement of reinforcement – total area = $A_{s,min}$

The area of reinforcement required by Equation 9.2.2 of AS 3600 should be distributed evenly on all faces of the column **Figure 5**. Note that it must be placed in the bottom and applies to all slabs, included flat plates, flat slabs with drop panels and band beam and slab connections, otherwise it will not be effective in providing membrane action to reduce the risk of collapse. Clause C9.2.2 of the AS 3600 Commentary provides the background to these requirements. Referring to **Figure 2**, it can be seen that the top cover was lost and the top reinforcement which was left exposed, was not effective at preventing collapse. The only reliable way to prevent collapse once you have a full thickness punching shear failure is having fully developed, ductile, bottom face reinforcement connecting the column core to the slab.

The structural integrity reinforcing bars are either spliced with existing bottom reinforcement in the slab in accordance with Clause 13.2 or AS 3600, or are provided as separate bars, extending a distance of $2L_{s,y.tb}$ past the face of the column or column capital. They should have hooked or cogged ends at discontinuous edges, including penetrations.

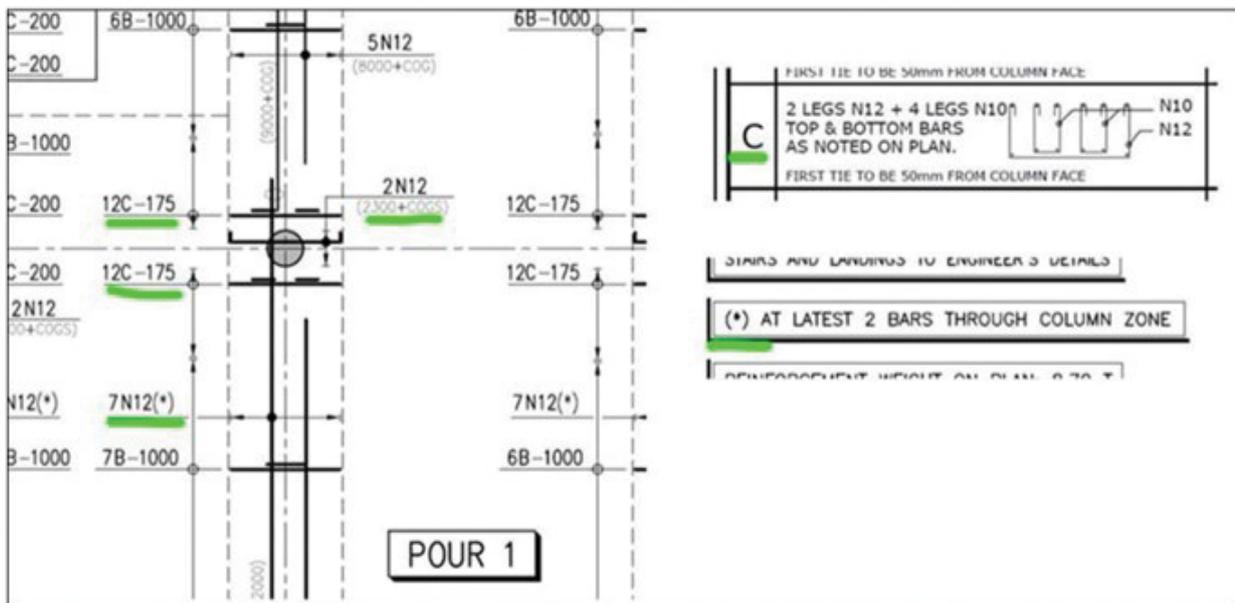
Figure 6 Example of nominal reinforcement to a slab band of a post-tensioned slab (from SRIA Technical Enquiry)

Note that the first paragraph of Clause 9.2.2 of AS 3600 specifically includes the connection of a slab band to a column, as slab bands are still subject to failures due to punching shear. Often, some nominal reinforcement is provided to slab bands within post-tensioned slabs (refer example in **Figure 6**), but slab bands cannot be considered as beams and the nominal reinforcement provided taken as satisfying structural integrity requirements based on the exemption given in Paragraph 2 of Clause 9.2.2 of AS 3600 which states that: “*Integrity reinforcement shall not be required if there are beams containing shear reinforcement and with at least two bottom bars continuous through the joint in all spans framing into the column.*” The reference to beams is intended to refer to members designed in accordance with Section 8 of AS 3600, for which separate structural integrity reinforcement requirements apply.

Structural integrity reinforcement in beams should also be provided with closed fitments, not the undesirable open fitments detailed in the **Figure 6** example (ie 'U' bars anchored with a 180° hook at the top), as the fitments provide no restraint to the compression side of the 'beam'. More information in this regard can be found in SRIA Technical Note 9 and Clause C9.2 of the AS 3600 Commentary.

As punching shear failure is sudden and cannot typically be restrained by taking into account the contribution from the main reinforcement in slabs, in the example shown in **Figure 6**, the minimum area of structural integrity reinforcement required in accordance with Equation 9.2.2 of AS 3600, $A_{s,min}$, should have been provided as bottom reinforcement over the column and distributed evenly on all faces of the column. Note that the area of the 2N12 bars in **Figure 6** can be taken as part of the minimum area of structural integrity reinforcement required.

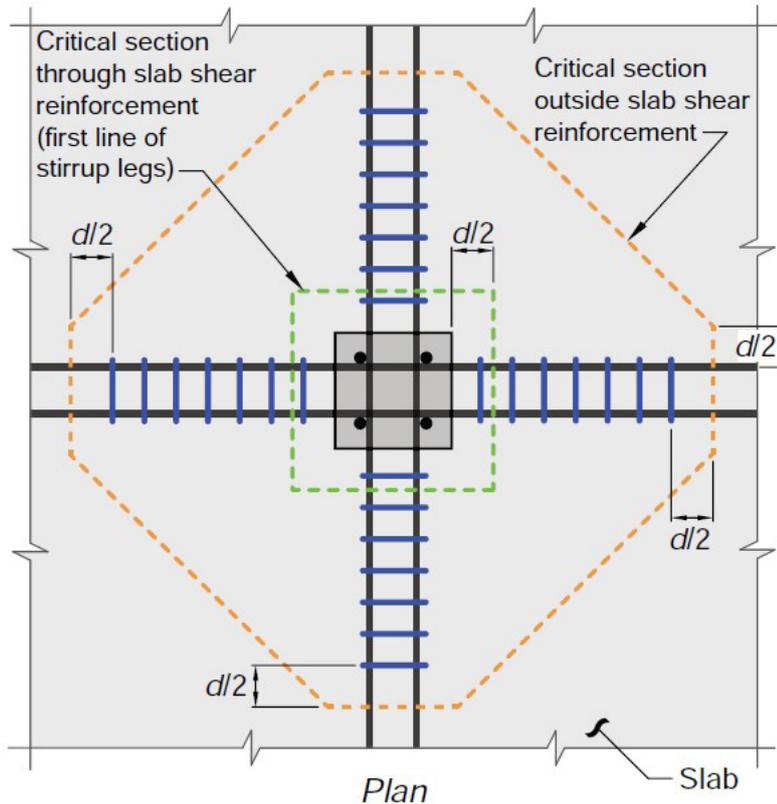
Figure 7 Critical sections for two-way shear in slab with shear reinforcement at interior column (Figure R22.6.4.2a from ACI 318M-19³)

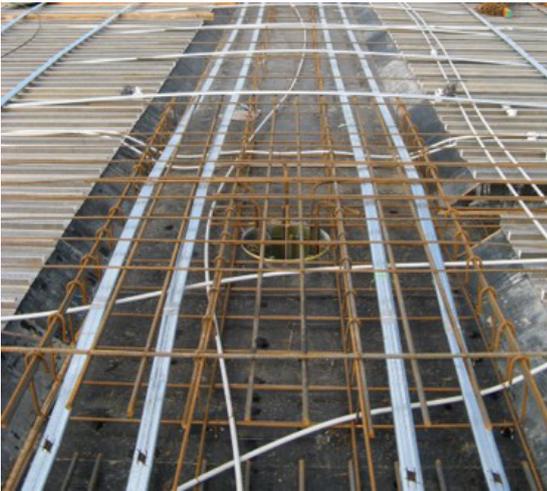
Figure 8 Post-tensioned slab band
(from SRIA technical enquiry)

Another issue that we come across is whether bonded slab post-tensioning systems can be considered as structural integrity reinforcement. Referring to **Figure 8**, there is no structural integrity reinforcement in the bottom of the slab band over the column. Note that the area of the post-tensioning tendons cannot be taken as part of the required structural integrity reinforcement as ducts are typically located in the top of the slab and/or slab band at column locations. Even if tendons were located over the column itself, C9.2.2 of the AS 3600 Commentary states that, “*Post-tensioning tendons within the column head in the top surface which would normally be considered to contribute to robustness based on a catenary model are not considered to contribute to the post punching shear failure capacity.*” This is because bonded tendons would be the first steel to fracture and thus provide no contribution to structural integrity reinforcement. The collapse of the post-tensioned carpark slabs shown in **Figure 9** demonstrates the importance of providing the required structural integrity reinforcement.

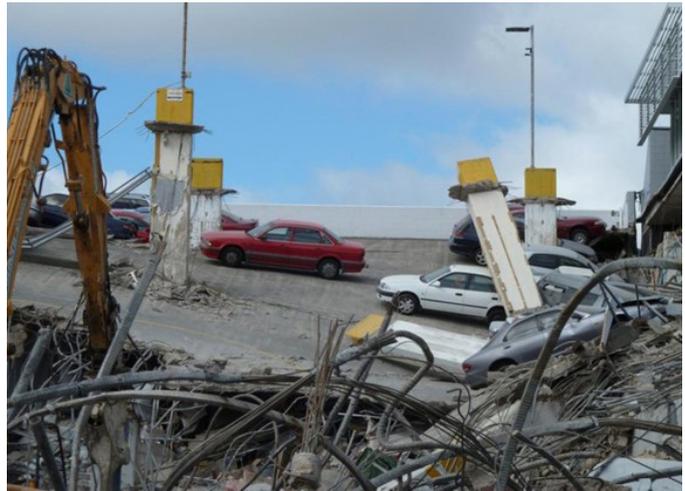
Figure 9 Remains of post-tensioned carpark floor at Christchurch, New Zealand showing punching shear failure at columns
(photograph courtesy Peter McBean)
